Client: 20796A Fox Creek Farm HOA

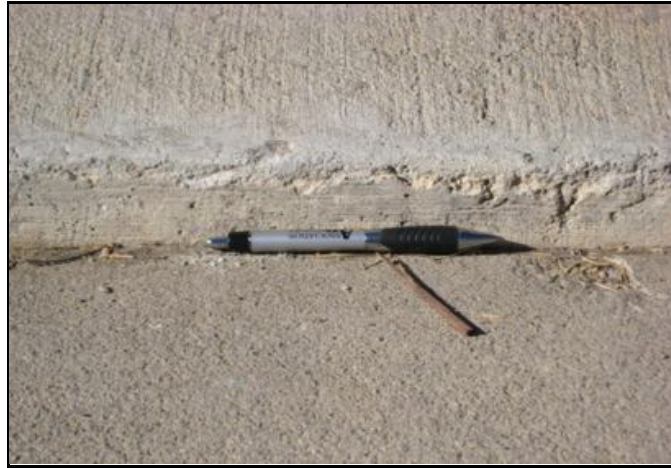
Comp #: 103 **Conc. Deck/Walk - Repair/Replace**

Evaluation: Extensive concrete is in overall good condition with isolated areas of settlement. Recommend repairing any trip/fall hazards immediately and inspect yearly for any ongoing damage. Repair and replace concrete to mitigate any subsurface moisture which will accelerate deterioration. Allowance includes concrete swales at detention ponds.

Lower allowance to partially repair and replace

Higher allowance to partially repair and replace

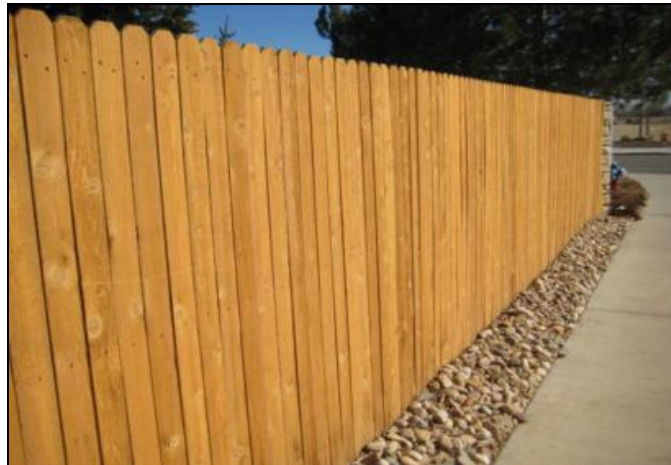
Comp #: 505 **Wood Fence - Replace**

Evaluation: Wood fence is in good condition with no significant signs of damage. Useful life may vary depending on lumber grade of cedar used, post integrity (how well they are secured), and exposure to the elements. Recommend yearly inspections to ensure fence is intact.

\$25/LF - Lower estimate to replace

\$30/LF - Higher estimate to replace

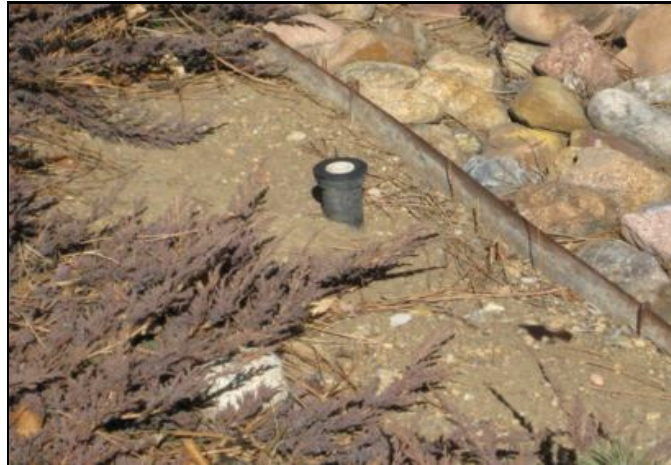
Comp #: 1001 Irrigation/Backflow - Replace/Upgrd

Evaluation: Funding is for an ongoing cycle of partial replacement of irrigation system, due to age, changing technology in water saving devices and damage caused by maturing trees/roots.

Lower allowance to partially replace and upgrade system

Higher allowance to partially replace and upgrade system

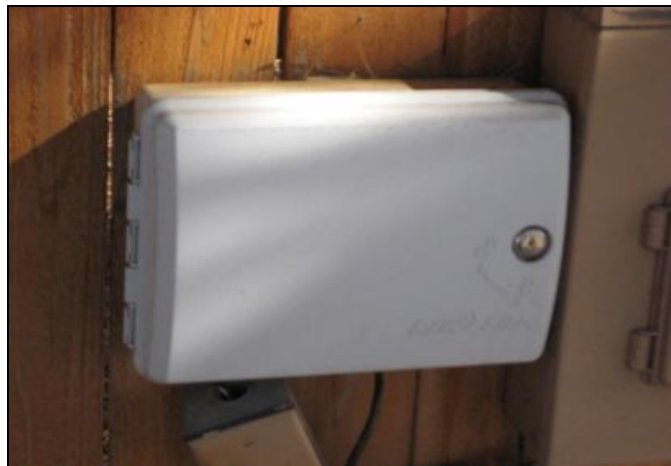
Comp #: 1003 Irrigation Controllers - Replace

Evaluation: Controllers are reported to be working. Funding anticipates replacing clocks on a cyclical basis with no expectations of replacing all of them at the same time. Funding includes upgrading controllers due to changing technology in water saving devices.

Lower allowance to replace 1 controller

Higher allowance to replace 2 controllers

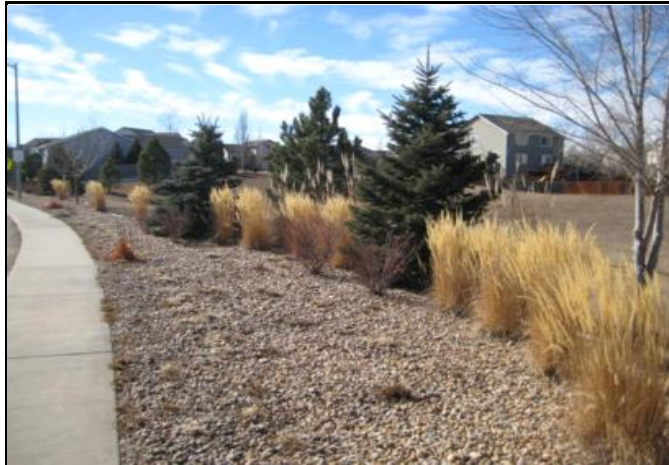
Comp #: 1005 Trees - Replace (partial)

Evaluation: Trees and vegetation are mature and appear in overall good condition. Funding is for ongoing replacement of trees and vegetation due to winter kill and disease. Funding includes any minor work in detention areas for maintaining drainage.

Lower allowance to replace trees and vegetation

Higher allowance to replace trees and vegetation

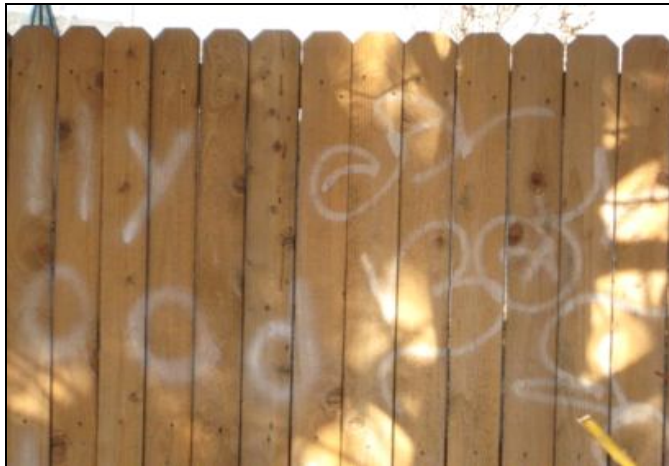
Comp #: 1109 Wood Fence - Restain

Evaluation: Wood fence is in good condition with isolated areas of graffiti. Recommend sealing fence on a regular basis to maintain appearance.

\$3.25/LF - Lower estimate to restain 1 side

\$3.75/LF - Higher estimate to restain 1 side

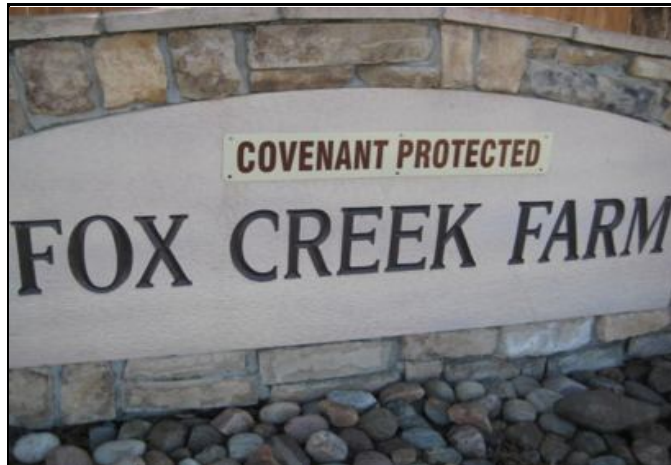
Comp #: 1402 Signage/Monument - Refurbish

Evaluation: Monument signs vary in condition. Recommend ongoing inspections of stone and lettering to ensure appearance. At this time, no expectation for a complete replacement. Funding is for ongoing refurbishment of stone and lettering. Funding includes any repairs to stone work on monuments and columns.

Lower allowance for refurbishment

Higher allowance for refurbishment

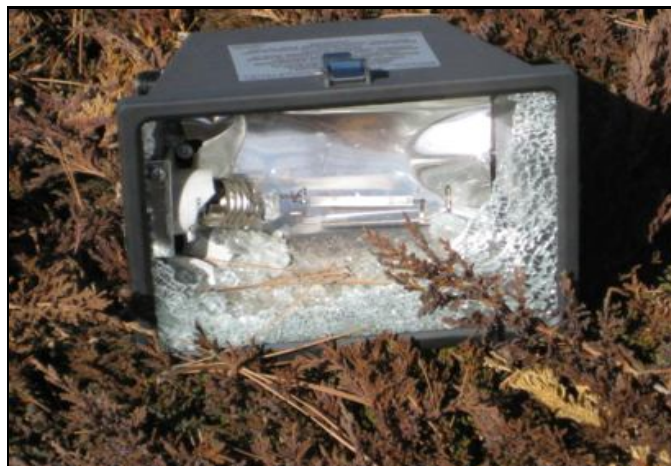
Comp #: 1505 Landscape Lights - Replace

Evaluation: Landscape lights vary in condition from good to poor. As noted, at time of inspection isolated lights were damaged. Funding is for ongoing replacement with no expectation for a complete replacement of all lights at the same time.

Lower allowance to partially replace lights

Higher allowance to partially replace lights
